SST COLD SPRAY TECHNOLOGY KEEPING HISTORICAL AIRCRAFT AIRWORTHY - CHIPMUNK ENGINE RESTORATION

CASE STUDY September 2020

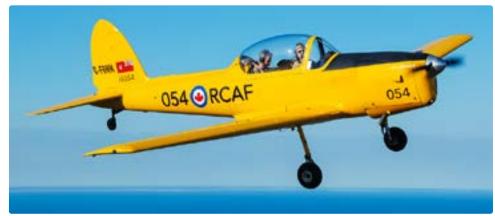
Figure 1. Chipmunk aircraft repaired by Cold Spray (Courtesy of the Canadian Historical Aircraft Association)

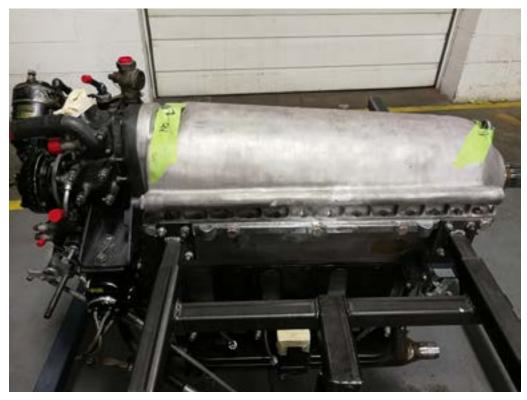
Figure 7. Gipsy DH Major 10MK1-3A engine assembled and readied for delivery
