A classic car restoration company, RX Autoworks from Vancouver, British Columbia Canada, contacted Supersonic Spray Technologies for assistance in restoring an oil pan on a 1937 Alfa Romeo 8C 2900B Touring Berlinetta (Figure 1).

### THE PROBLEM

### THE SOLUTION

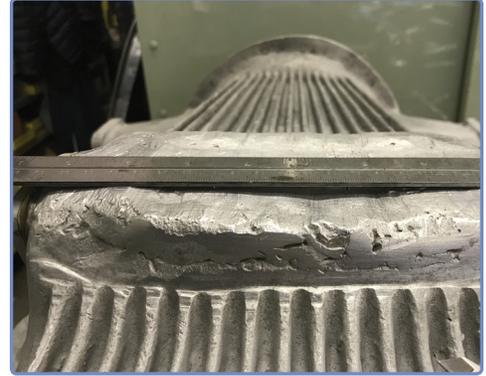
Wear/tear and corrosion over the years had a severe impact on the aesthetics and functionality of the aluminum casting oil pan. There were visible cracks on the inside of the oil pan that were causing leaks. The outside of the pan did not look aesthetically pleasing (Figure 2). Replacing components on vintage vehicles is undoubtedly not an option as they are long out of production. Additionally, aluminum casting alloys used to fabricate components like this are heat treated and are sensitive to procedures such as welding or conventional thermal spray techniques. Therefore, selecting a repair technique that did not compromise the integrity of this one of a kind component was paramount.

Figure 2 - Leaks caused by visible cracks and unacceptable aesthetics inside and outside the oil pan.

SST cold spray process enables metal consolidation than can dimensionally restore heat-sensitive components with minimal or no thermal effects. Therefore, SST manual cold spray technology, operating at low pressures and temperatures, was considered a reliable and effective solution for this challenge. The SST job shop team prepped the parts and applied cold spray to repair the damage (Figure 3).

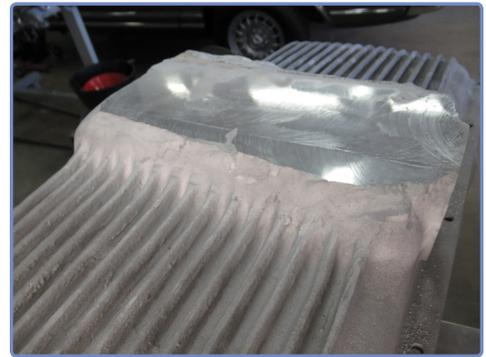
Figure 3 - Cold sprayed oil pan prior to machining.

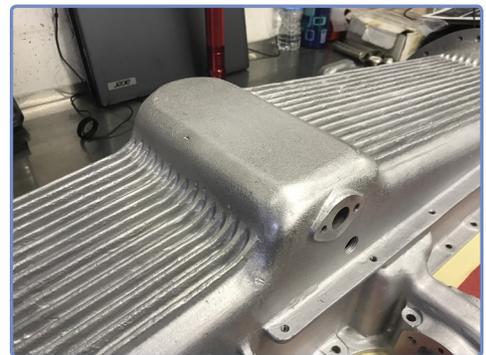
Figure 4 - Restored oil pan.

Final machining was completed by RX Autoworks. SST was successful in restoring the original oil pan to full mechanical functionality (stopped the leaks) and aesthetically to its original appearance (Figure 4).

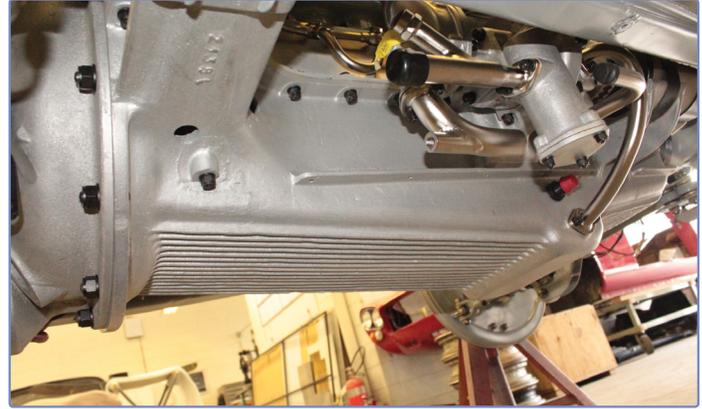
Figure 5 - Finished oil pan installed.

This repair (Figure 5) was achieved with the following SST equipment and parameters:

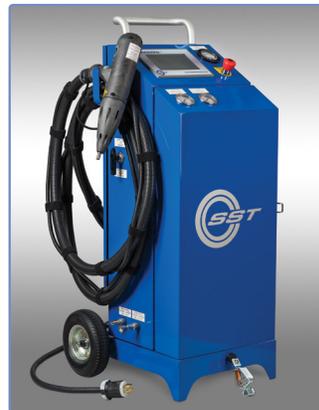
Spray System: Series P with manual spray gun and 2.0 mm UltiLife™ nozzle. (Figure 6)

Figure 6 - Series P Spray Machine.

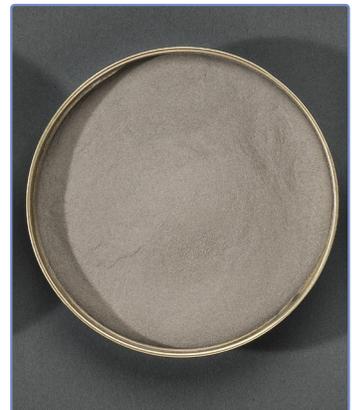
Powder: SST-A0050 (aluminum) (Figure 7)

Figure 7 - SST-A0050 Aluminum Powder.
