Award-Winning 1937 Alfa Romeo Gets a Boost with Cold Spray

Challenges during Restoration

The Cold Spray Choice

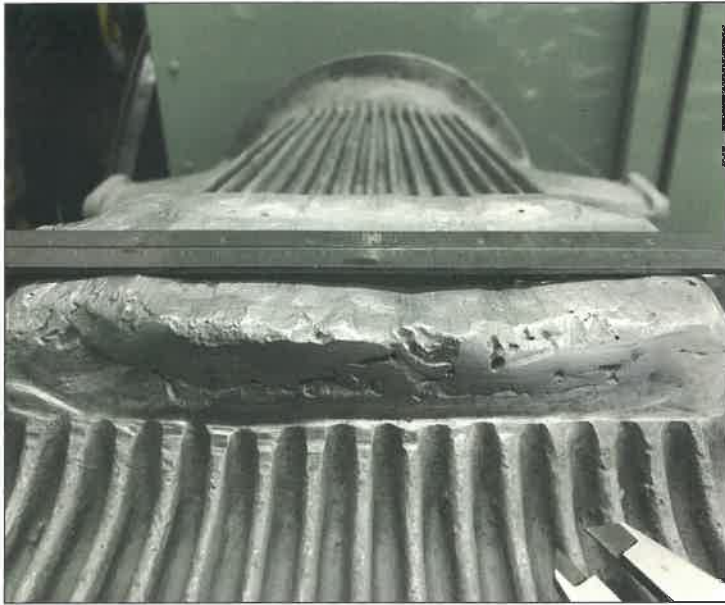
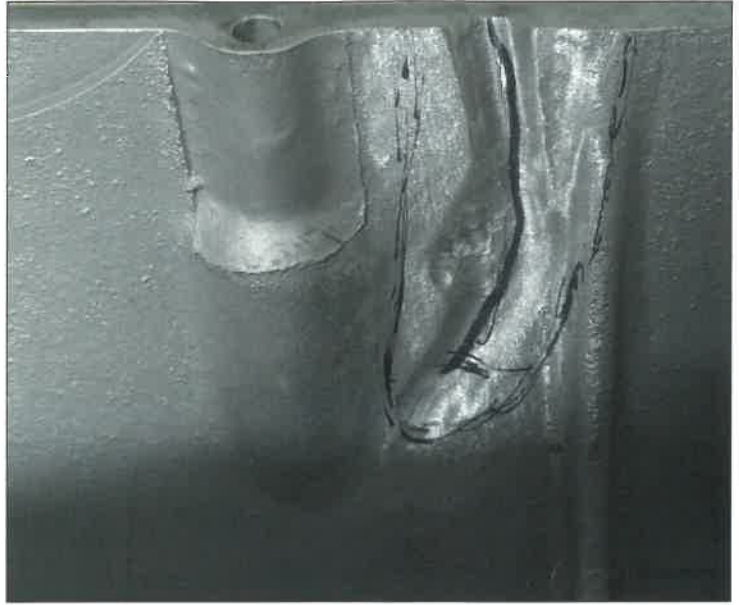
Fig. 1 — Visible cracks and unacceptable aesthetics are seen around the oil pan.

In trying to restore the car to its original condition under the hood, many challenges were faced. Corrosion, tear, and wear had damaged both the aesthetics and functionality of the cast aluminum oil pan. There were visible cracks on the inside, unacceptable aesthetics on the outside, and multiple oil leaks during operation — Fig. 1. The aluminum cast alloys used to fabricate these components were all heat treated, making them quite sensitive to thermal repair processes such as welding or conventional thermal spray, for degraded mechanical properties and distortion. Replacing the old part with a new one wasn’t an option because these components went out of production a long time ago. Attempts had been made to dimensionally repair these defects by special welding methods, which still rendered poor performance results and worsened the aesthetic appearance. Consequently, the restoration professionals made an

Portable cold spray equipment offered an economically viable option to conduct the repair using nitrogen as a propellant and aluminum-based powder as the repair material — Fig. 2. After low-temperature dimensional restoration of the area, the new consolidated material was effectively machined back to tolerance using standard machining techniques.

The cold spray processes began with surface preparation, which consisted of cleaning, pre-machining for suitable deposition, and grit blasting. Then, an SST™ Series P machine was utilized to manually fill in all repair areas, using the spray parameters depicted in Table 1. The sprayed component was finally machined to desired dimensional tolerances — Fig. 3. The vehicle was then reassembled by a professional restoration shop (Ref. 1) to its original functionality and aesthetics — Fig. 4.

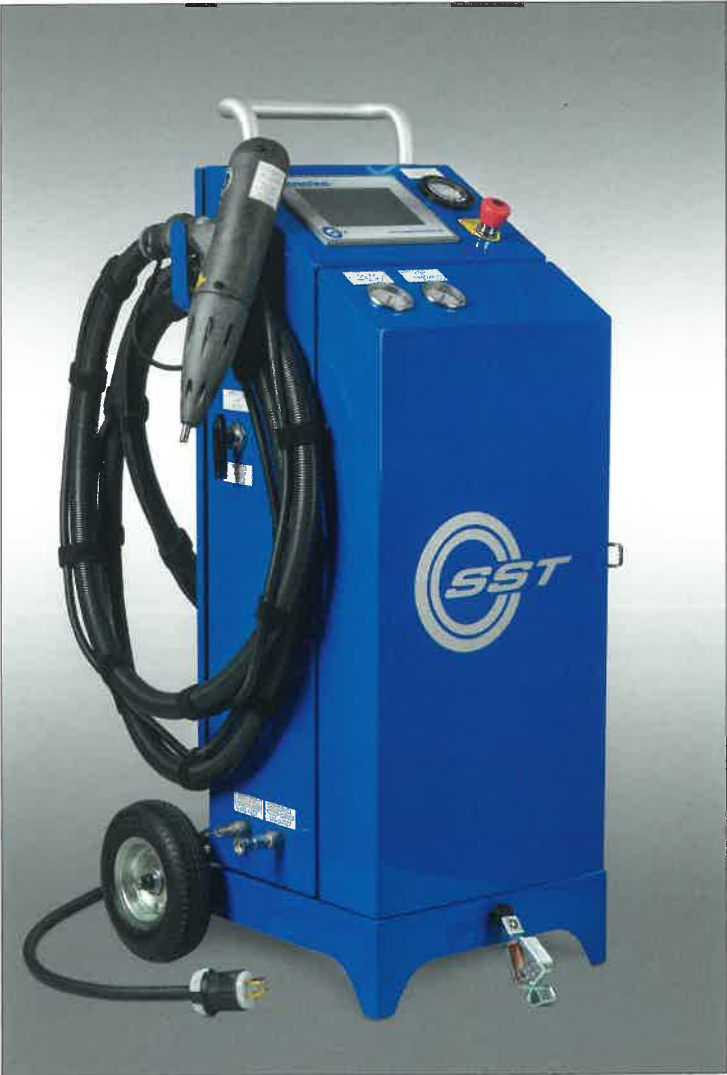
Fig. 2 — The commercial SST™ Series P cold spray system was used to conduct the oil pan restoration job. (Courtesy of CenterLine Windsor Ltd.)

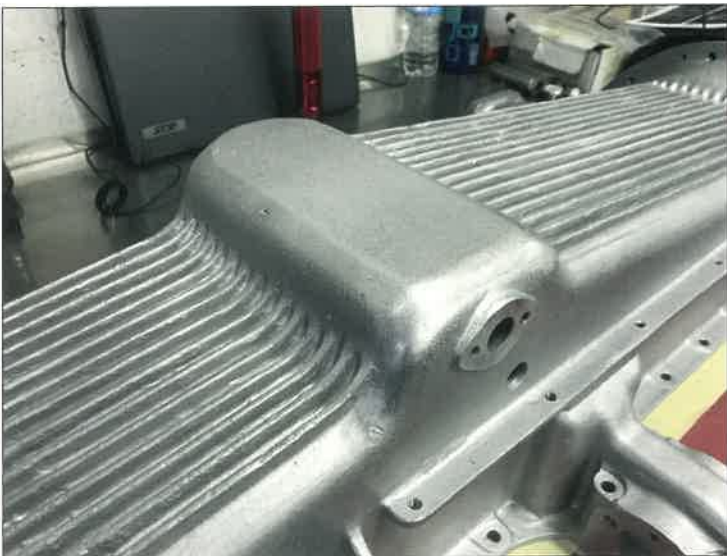
Fig. 3 — Restored oil pan. (Courtesy of RX Autoworks.)

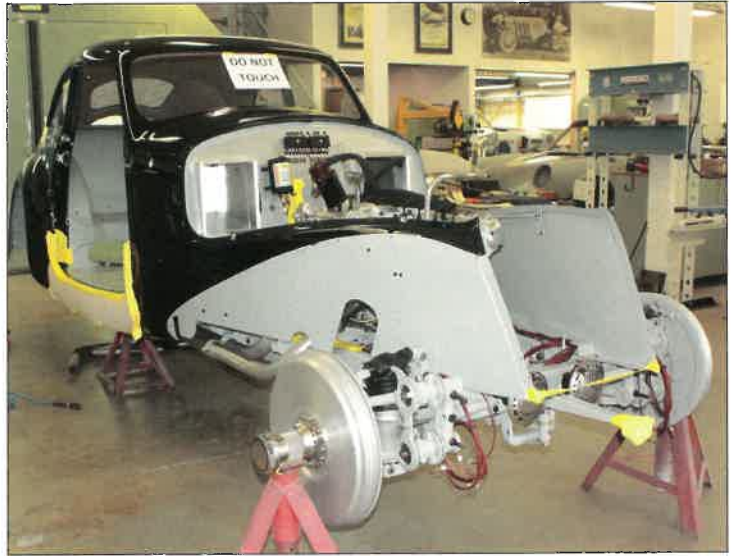
Fig. 4 — The vehicle is reassembled following the restoration of the oil pan. (Courtesy of RX Autoworks.)
