# Historical Aircraft Soars with Cold Spray Technology

*This process allows the restoration of vintage engines*

BY JULIO VILLAFUERTE

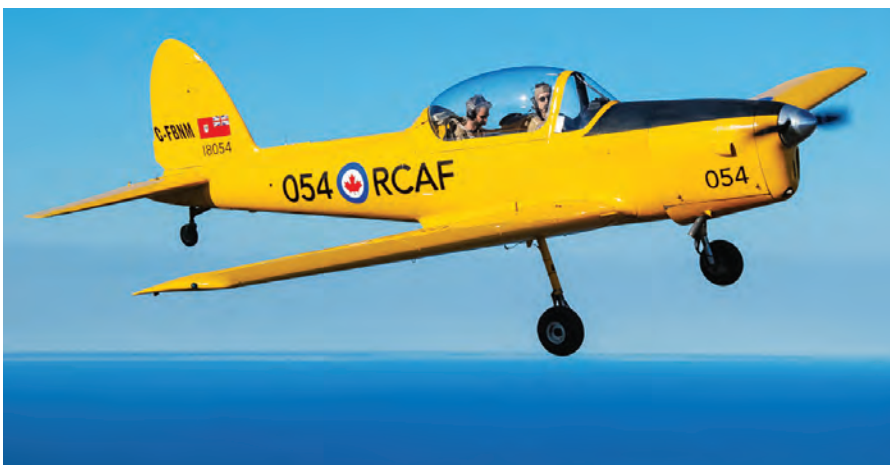
*A Chipmunk aircraft repaired by cold spray. (Photo courtesy of the Canadian Historical Aircraft Association.)*

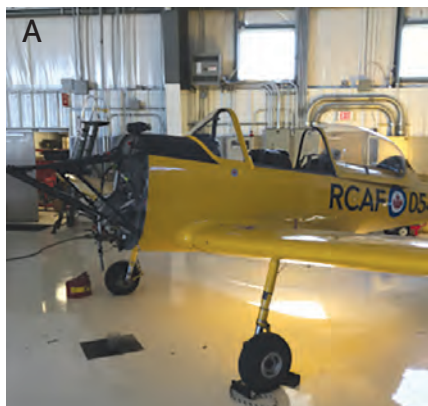
Fig. 1 — A — Gipsy DH Major 10MK1-3A engine overhaul; B — liquid penetrant NDE of the cover; C — liquid penetrant NDE of the lower crankcase.

Mechanical wear and tear had put a toll on the integrity of the engine casing of a Chipmunk DHC-1 aircraft. During overhaul of the Gipsy DH Major 10MK1-3A engine, following the Canadian Historical Aircraft Association's TC-approved *Maintenance Manual*, unacceptable cracking of a flange area and bolt holes of the lower crankcase and upper cover were discovered by the liquid penetrant nondestructive examination (NDE) method (Ref. 1) — Fig. 1. These cracks put the mechanical integrity of the engine at risk by allowing engine oil to leak out. One of the flaws included a through-thickness crack at the root of the flange, which caused detachment of the flange and thus eradication of one fastening post to the lower crankcase.

The materials of the top cover and lower crankcase were magnesium and aluminum cast alloys, respectively, which would not tolerate elevated-temperature repair processes, such as welding.

Both the top cover and the lower crankcase were assessed for restoration by cold spray. Due to the already weakened condition of the material, it was recommended that both the cracked flange at the cover and the cracked region on the lower crankcase be completely removed.

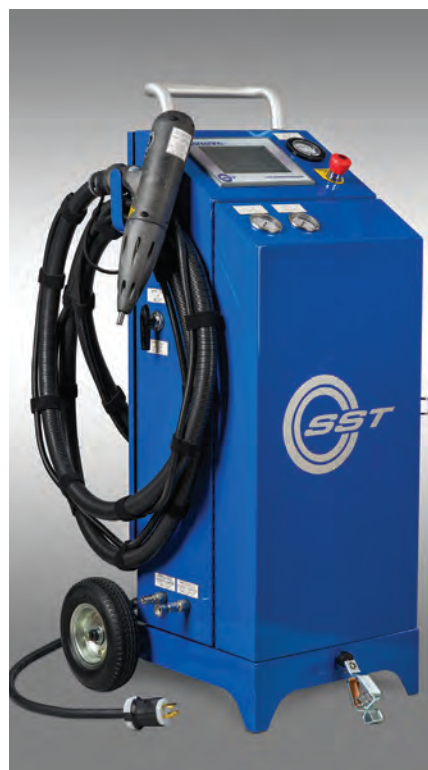
Fig. 2 — Commercial SST Series P cold spray system.

Cold spray is a solid-state metal consolidation process that uses a high-speed gas jet to propel metal and other powder particles against a substrate where particles plastically deform and consolidate upon impact. The term cold spray refers to the relatively low temperature involved in the process, which is typically much lower than the melting point of the spray material and substrate. In the Supersonic Spray Technologies (SST™) cold spray equipment, air can be used as a propellant gas and temperatures will be low enough not to thermally disturb the substrate material. After low-temperature dimensional restoration of the area, the new consolidated material can be effectively machined back to tolerance using standard machining techniques. SST cold spray

offers the ability of all-metal consolidation for dimensional restoration in both manual and robotic applications — Fig. 2.
