SST Cold Spray Repairs Worn Bearing Seats

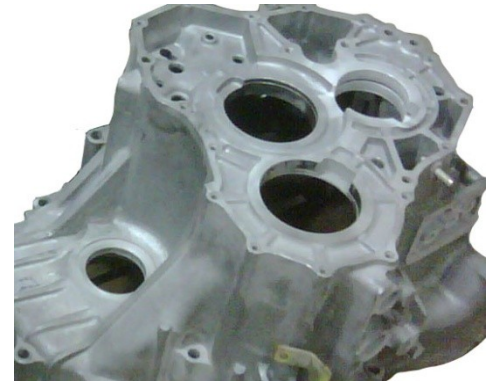
A major U.S.-based company that refurbishes automatic transmissions was seeking a solution to repair worn bearing seats on torque convertors. Fixing the uneven, eccentric wear around the ID circumference was challenged by the presence of a ring groove that limited the access to the repair area. The application required that the bond between the repaired metallic lining and the bearing seat be strong enough to allow for machining as part of the finishing process.
