Figure 1. Lancaster WW II bomber

RESTORATION CHALLENGES

THE SOLUTION

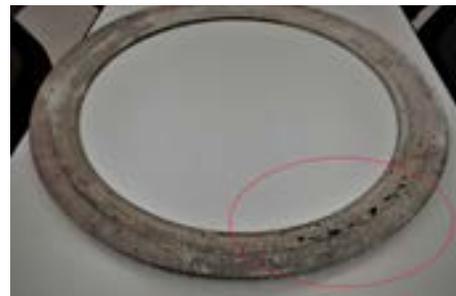
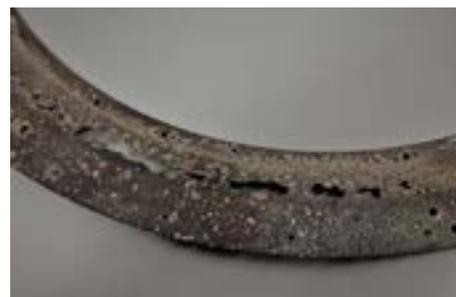
Airworthiness on these and any other historical airplanes is challenging, at best, due to the lack of spare parts and/or effective repair and restoration processes. Corrosion typically takes a toll on the aesthetics and functionality of components, many of which are made of treated materials that cannot tolerate elevated process temperatures. One such component is a ring belonging to the mounting assembly of the rear gun turret (**Figure 2**). Years of corrosion have created through-thickness holes affecting both aesthetics and the integrity of the assembly. These holes are difficult to restore with conventional thermal processes without affecting the integrity of the part.

Figure 2. (b) and (c) Part of the turret mounting assembly, heavily corroded showing through-thickness corrosion holes.

The steel ring was submitted cold spray repair. First, surface preparation consisted on cleaning and grit blasting. Then the SST SERIES P machine was utilized to manually fill in all repair areas, including through holes, using the spray parameters depicted in the table 1. In order to successfully fill in through-thickness holes with acceptable adhesion, a qualified cold spray operator used a step process consisting on slow buildup around the edges followed by grinding off to prepare the next buildup. The deposits were gradually bridged to close the hole. By repeating these, the good adhesion deposits were warranted for final post-spray grinding **(Figure 4)**.

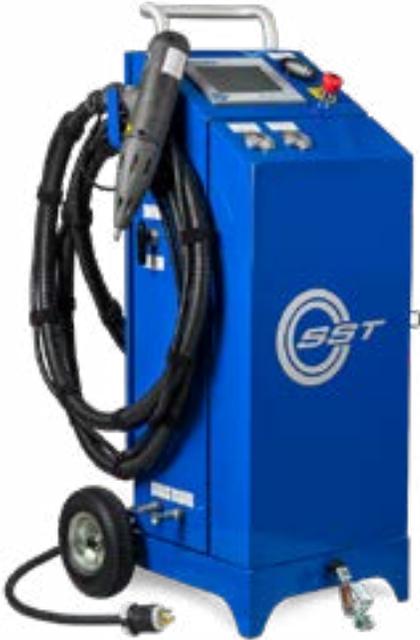
Figure 3. Commercial SST SERIES P Cold Spray Manual System

Cold spray is a solid-state metal consolidation process that uses a high-speed gas jet to propel metal and other powder particles against a substrate where particles plastically deform and consolidate upon impact. The term “Cold Spray” refers to the relatively low temperature involved in the process which is typically much lower than the melting point of the spray material and substrate. In the SST cold spray equipment, air can be used as a propellant gas and temperatures will be low enough not to thermally disturb the substrate material. After low-temperature dimensional restoration of the area, the new consolidated material can be effectively machined back to tolerance using standard machining techniques. SST Cold spray technology offers the ability of all metal consolidation for dimensional restoration both manual or robotic application **(Figure 3)**.

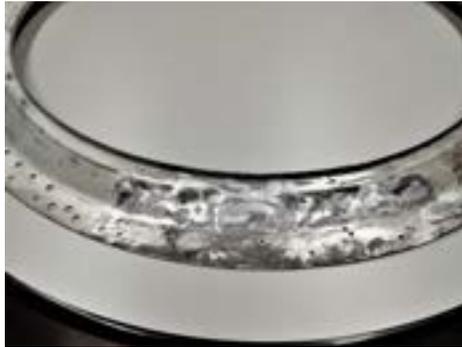
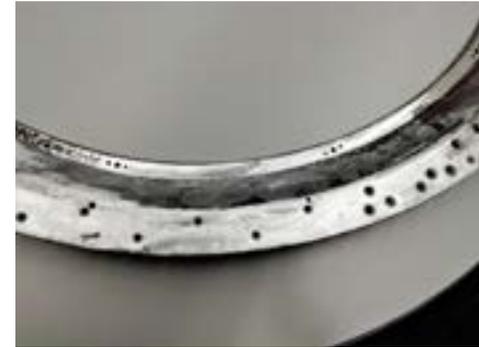
Figure 4. Component cold sprayed and grinded

Machine: SST SERIES P / Manual Gun / 2.0MM Orifice / UltiLife™ nozzle
Spray Powder: SST A0050 (Aluminum – Alumina)
Substrate: Heat treated steel
Gas: Nitrogen
Surface preparation: grit blasting with Grit 80
Gas Temperature: 400 C
Gas Pressure: 180 psi (13 bar)
